1. Techtip

Automotive Airconditioning Reporter

Honda

➤ *A/C system doesn't work, or, it does work but does not disengage*

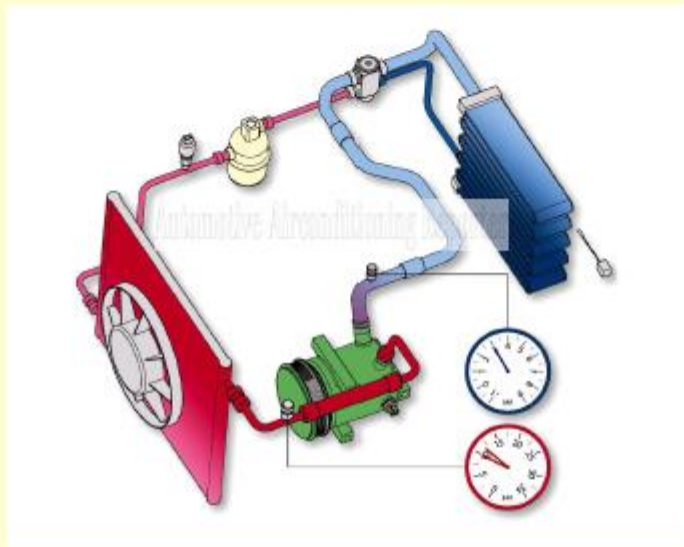
Compressor type	Variable (externally controlled)
Expansion Device	Expansion Valve
Pressure High Side	Ranges from normal to low (see gauge)
Pressure Low Side	Too high (see gauge)
Temperature suction line	Not cold enough
Complaint	No or little cooling

- Disturbance in compressor control mechanism (control valve, electrical signal to compressor, disturbance in control unit), compressor does not get to its maximum displacement level
- Excessive heat load to the evaporator, in most cases the evaporator lacks capacity by design
- Part of the evaporator is clogged

Remarks: the high side pressure will be lowish.
